PERFORMANCE EVALUATION OF IOWA BRIDGE DECKS CONSTRUCTED WITH EPOXY-COATED REINFORCING BARS

Final Report

August 19, 2011

Iowa Department of Transportation

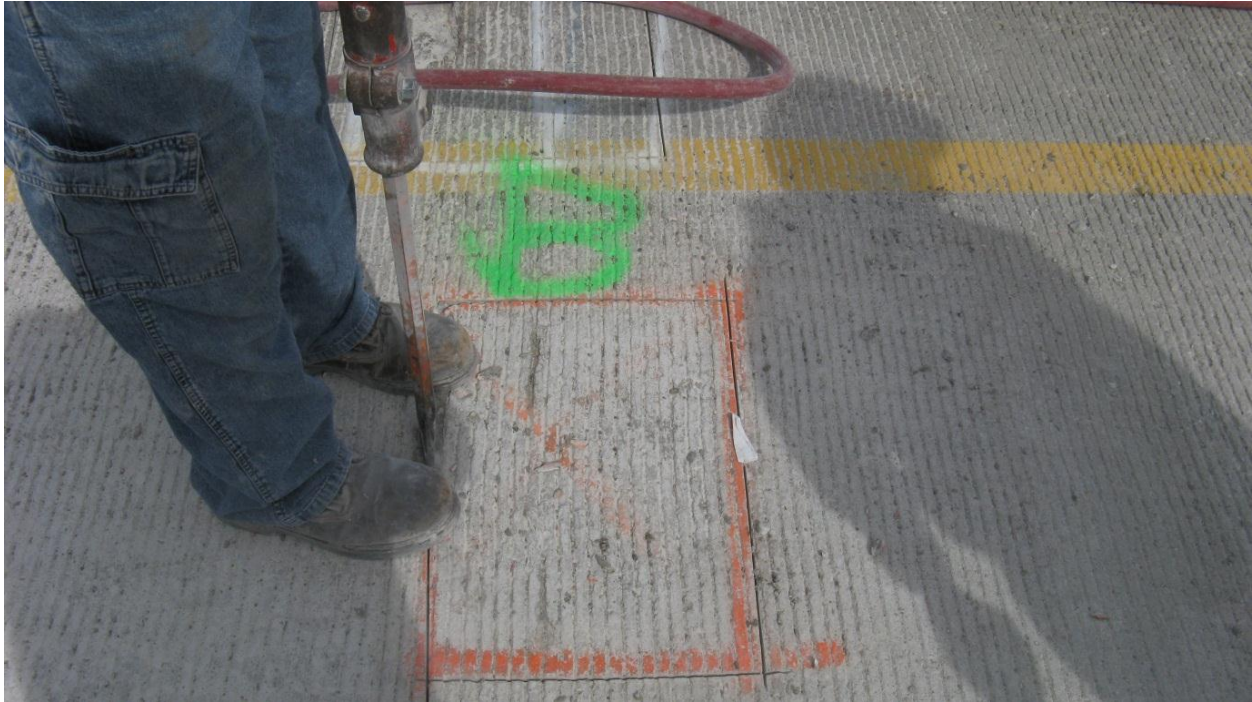
Figure 1. Concrete removal process at deck patching performed by Iowa DOT maintenance personnel at Southbound US 65 Bridge over the Union Pacific Railroad in Bondurant, Iowa (photography courtesy of Iowa DOT).

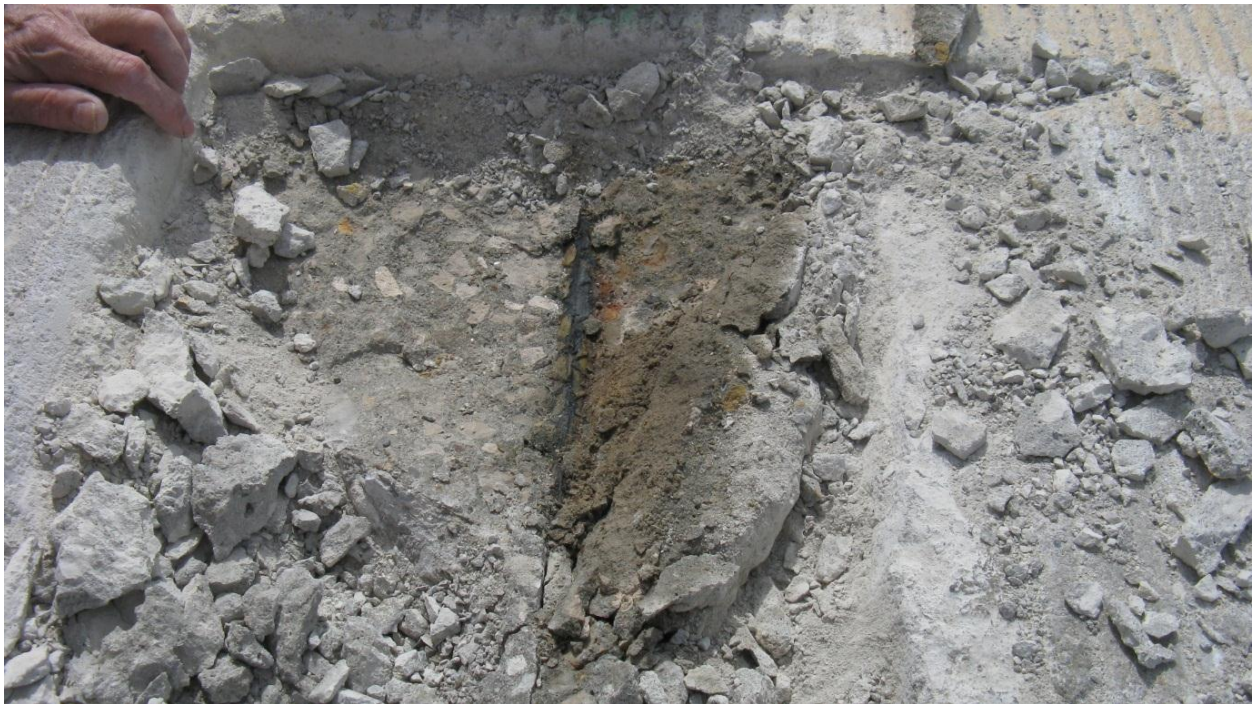
Figure 2. Corroded reinforcing bar exposed during the deck patching performed by Iowa DOT maintenance personnel at Southbound US 65 bridge over the Union Pacific Railroad in Bondurant, Iowa (photograph courtesy of Iowa DOT).

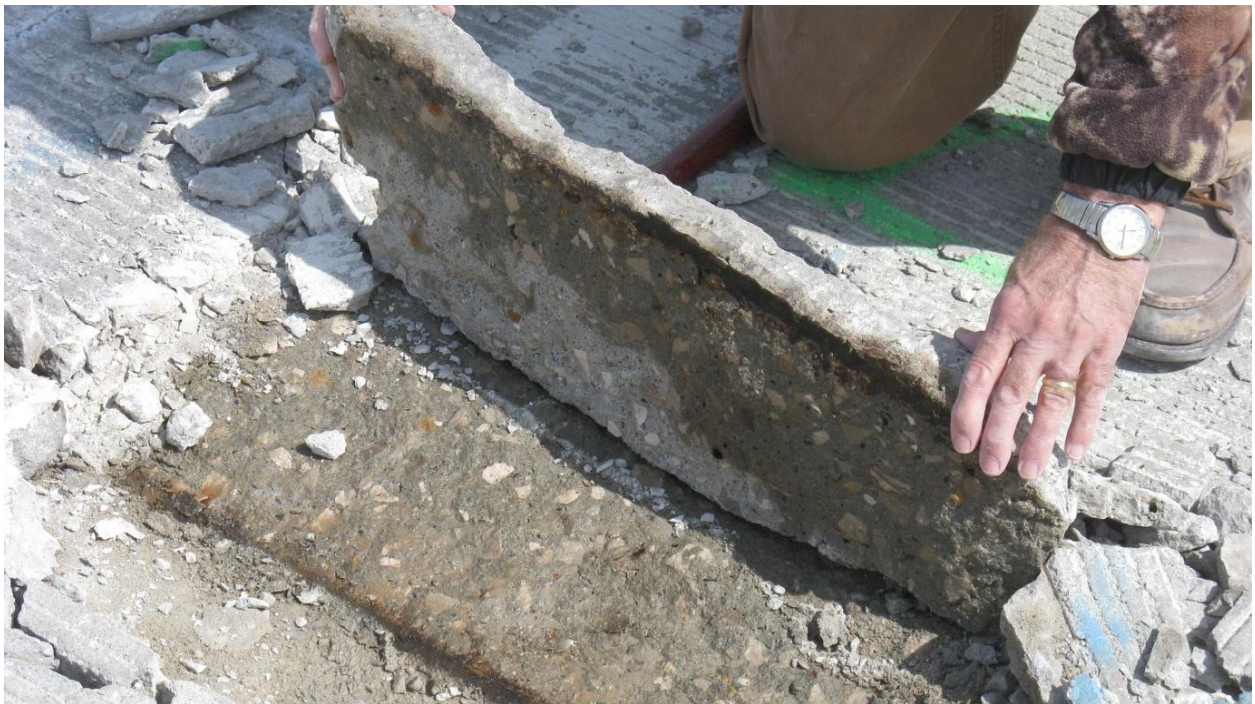
Figure 3. Delaminated section of concrete at a corroded reinforcing bar exposed during the deck patching performed by Iowa DOT maintenance personnel at Southbound US 65 Bridge over the Union Pacific Railroad in Bondurant, Iowa (photograph courtesy of Iowa DOT).

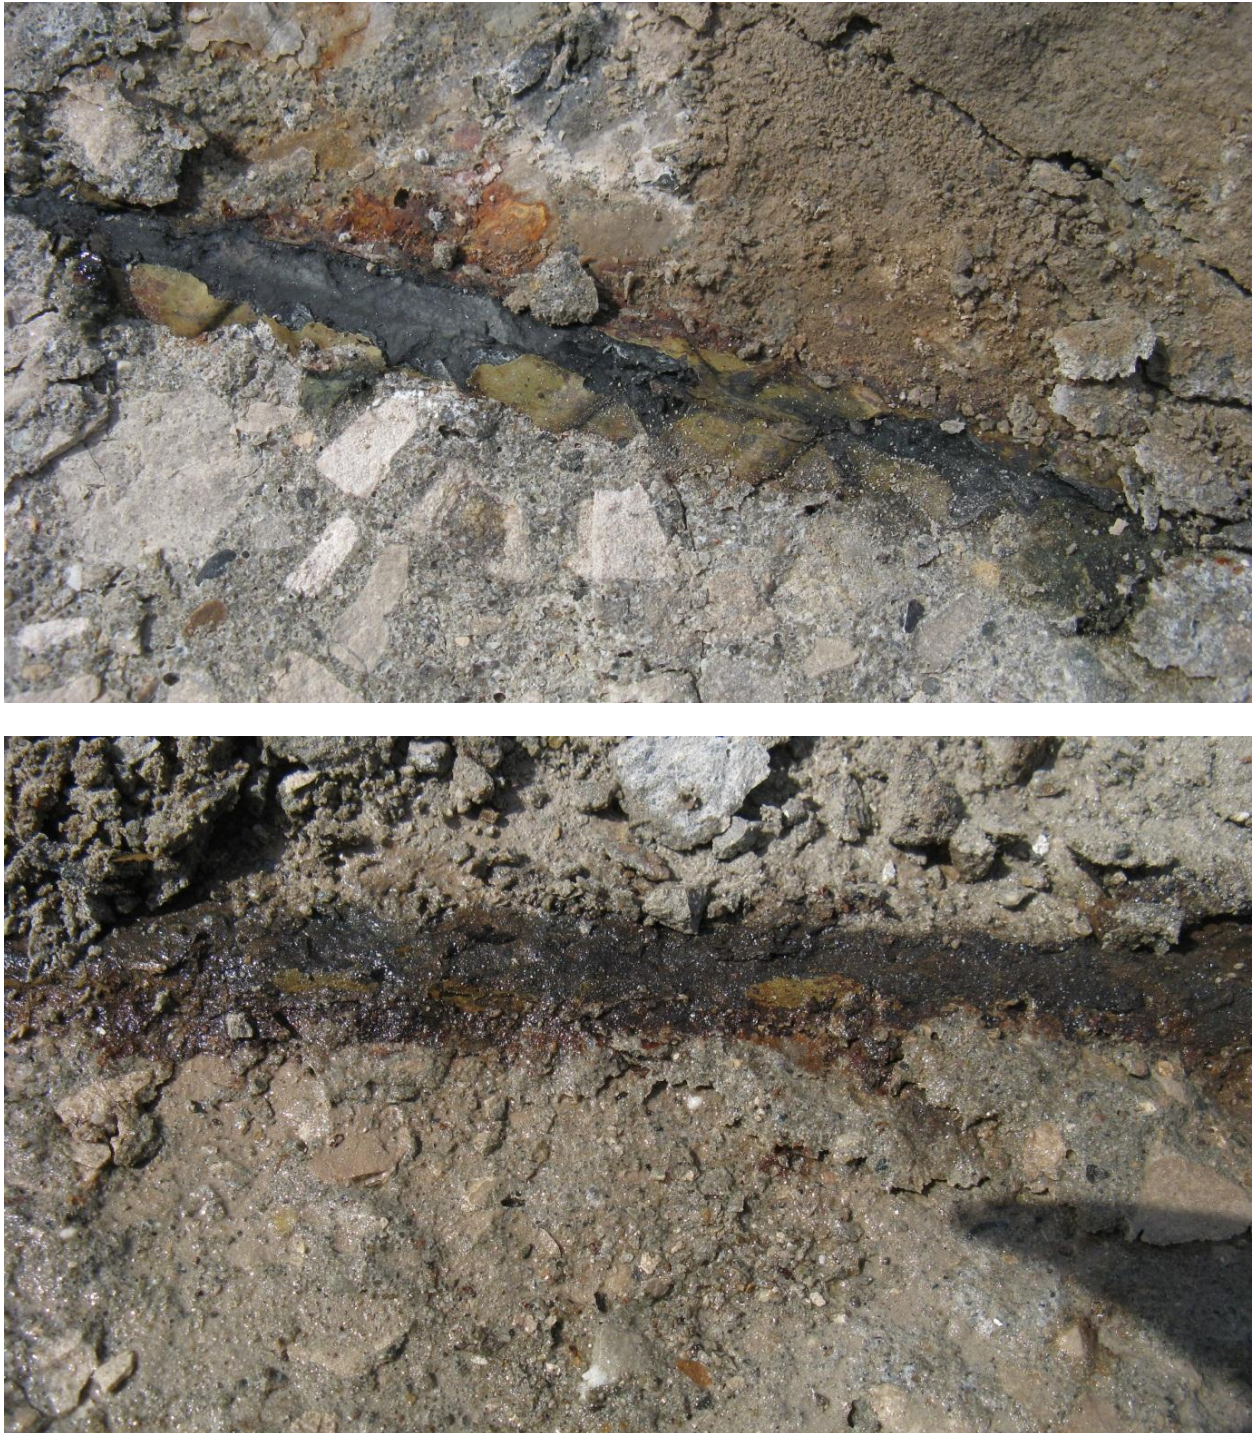
Figure 4. Close-up views of corroded epoxy-coated reinforcing bars uncovered during deck patching performed by Iowa DOT maintenance personnel at Southbound US 65 Bridge over the Union Pacific Railroad in Bondurant, Iowa (photograph courtesy of Iowa DOT).

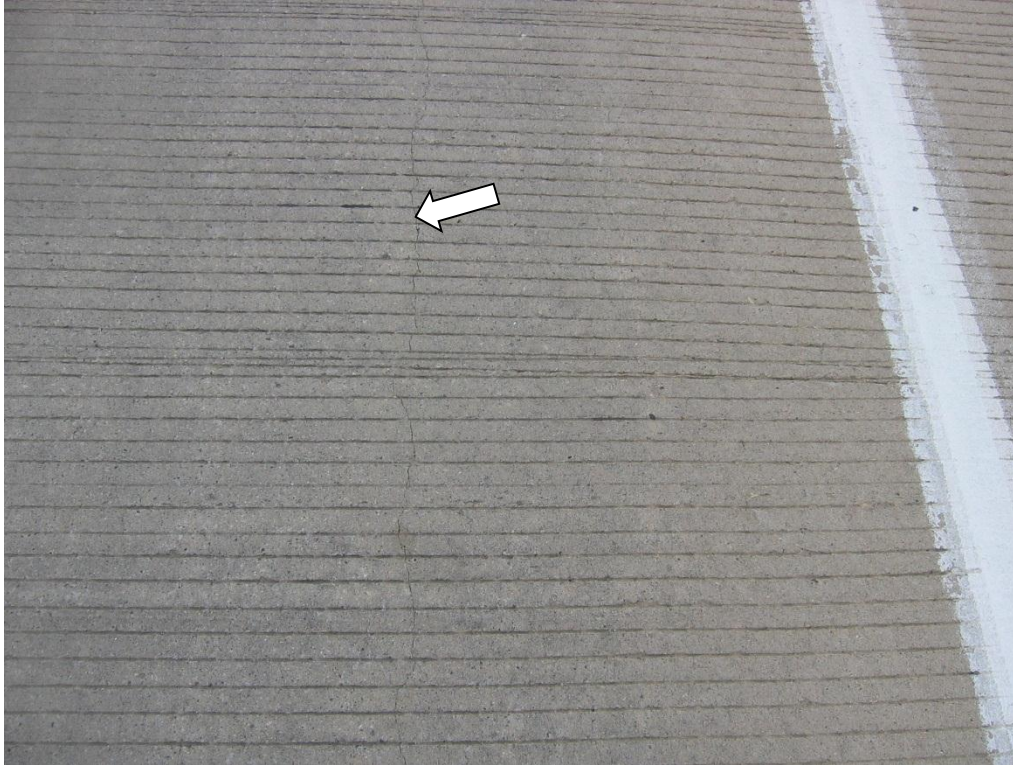
Figure 31. Typical longitudinal crack in wheel path of approach spans at Southbound US 218 bridge.

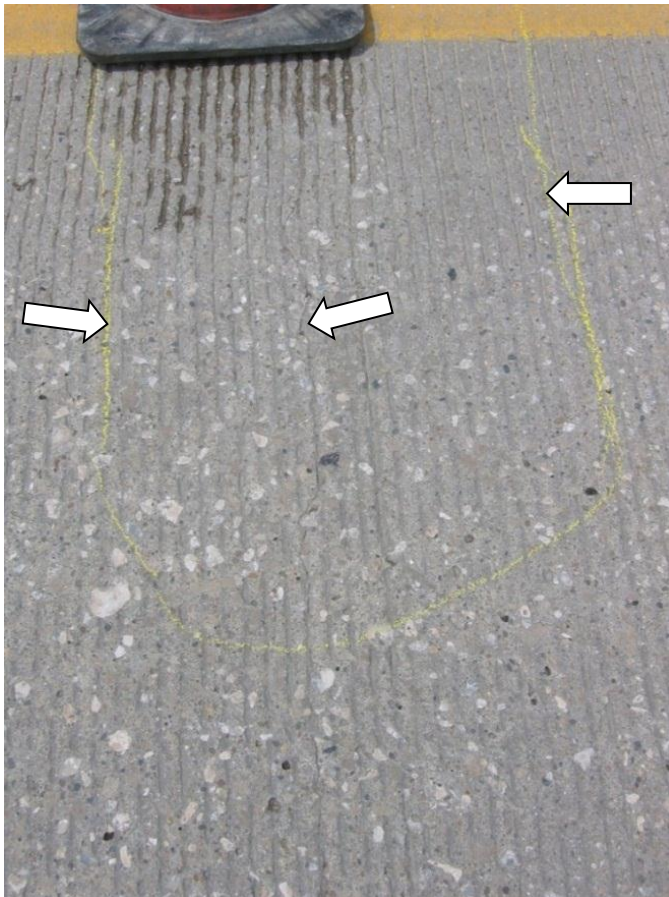
Figure 32. Area of delaminated concrete (outlined in yellow) at a transverse crack in the IA 150 bridge deck.

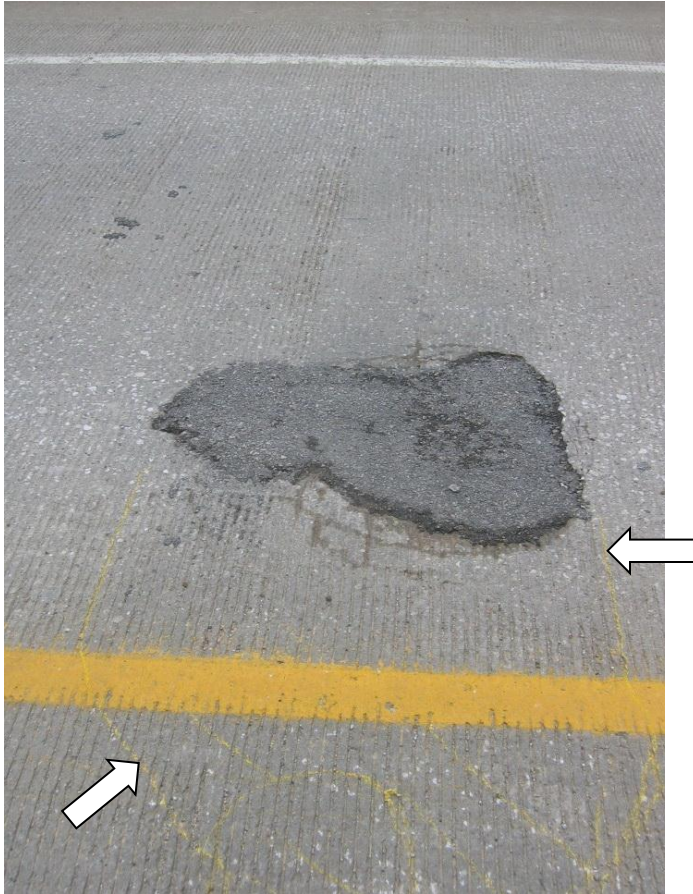
Figure 33. Asphalt patch on IA 150 bridge deck, with areas of continued delamination marked in yellow.

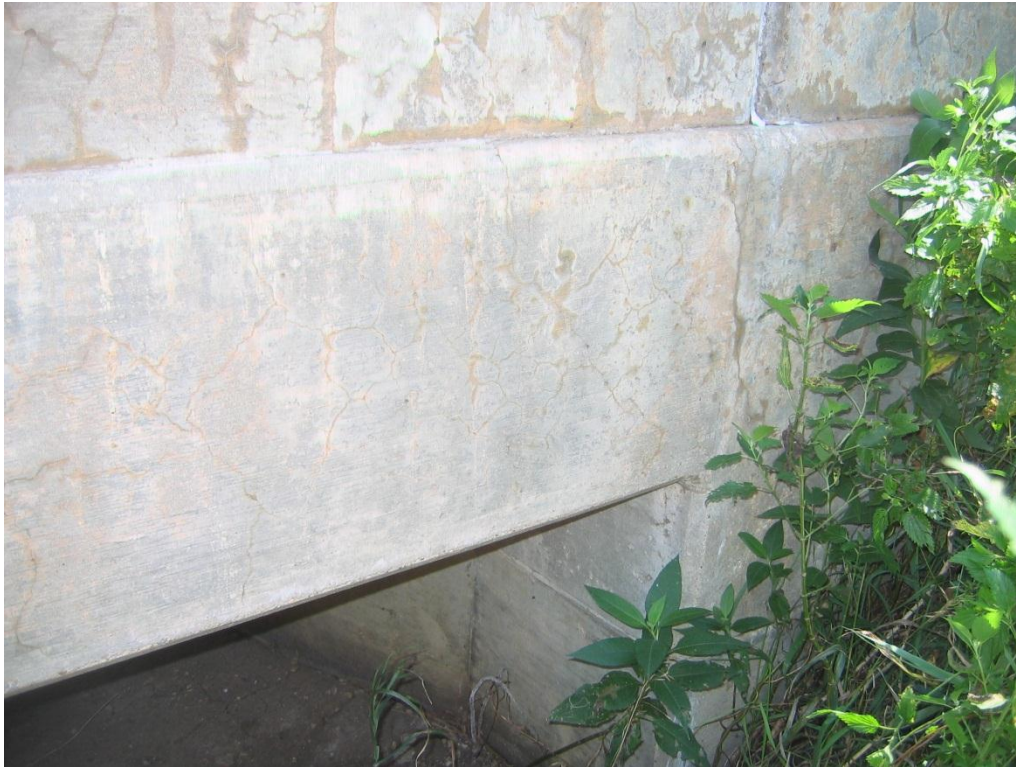
Figure 37. Hairline cracking in edge of deck slab and barrier rail at southwest corner of the Southbound Iowa 13 bridge deck.

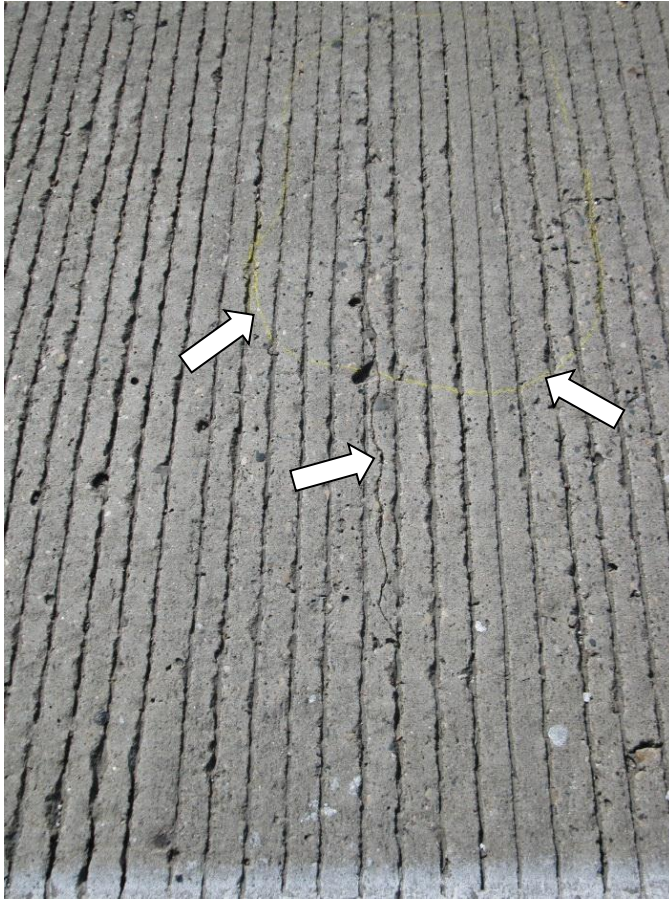
Figure 39. Typical transverse crack in east approach spans of US 30 bridge deck. Note delamination outlined in yellow (see arrows)

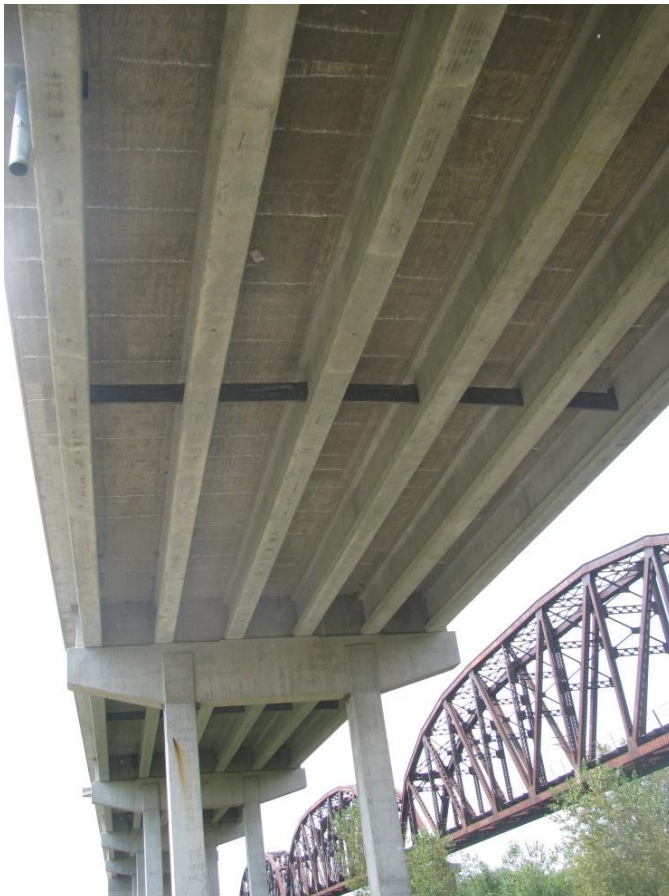
Figure 40. Regular through deck transverse cracks highlighted by efflorescence on the underside of east approach spans for the US 30 bridge deck

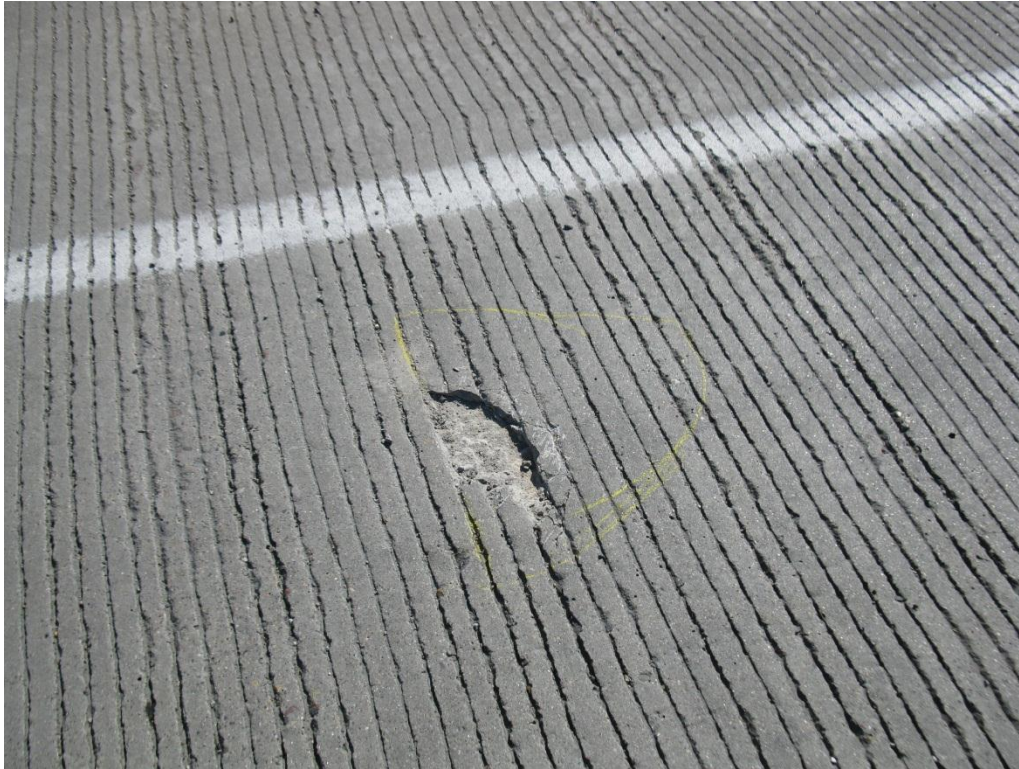
Figure 41. Incipient spalling at an area of delaminated concrete on the US 30 bridge deck.

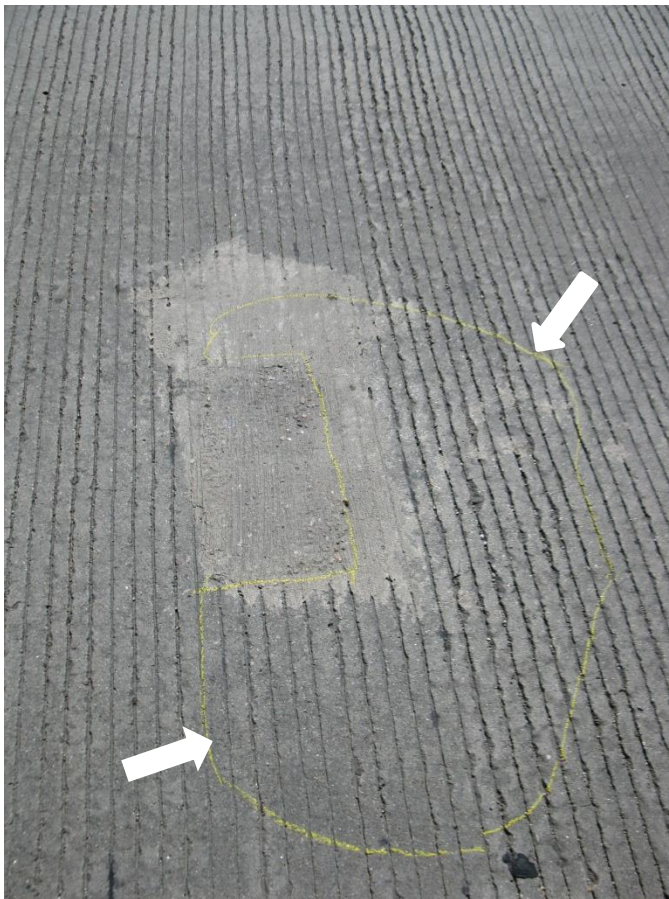
Figure 42. Area of delaminated concrete (outlined in yellow) immediately adjacent to an existing patch on the west approach spans of the US 30 bridge

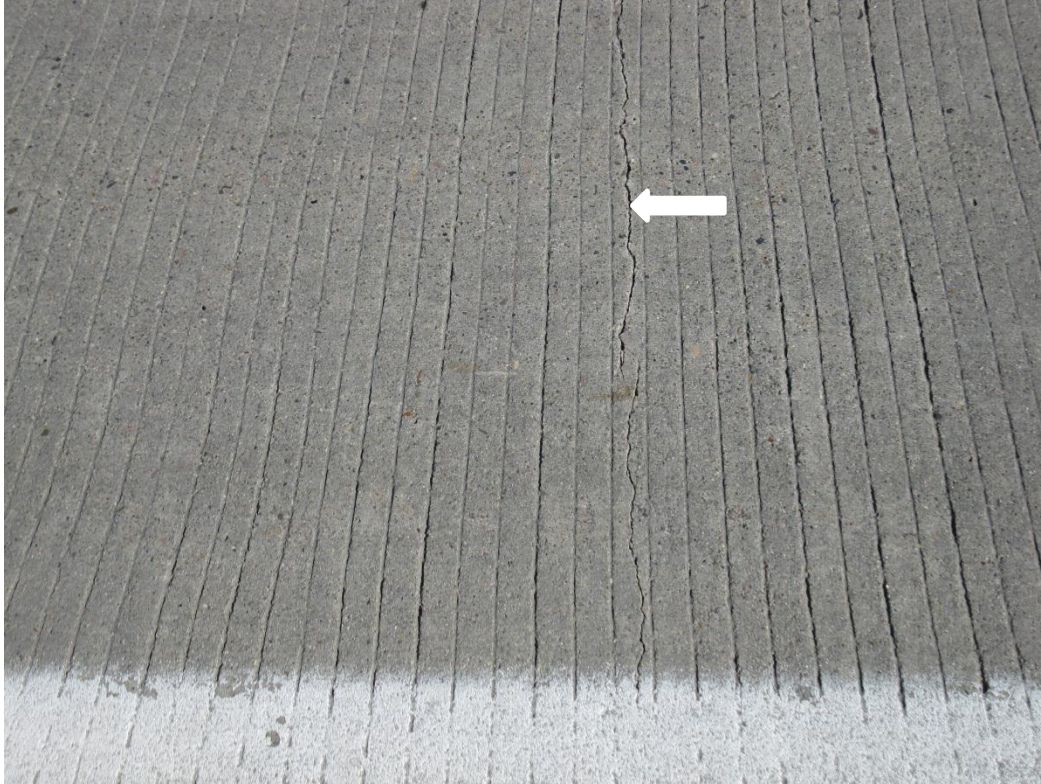
Figure 43. Typical transverse crack in US 30 bridge deck.

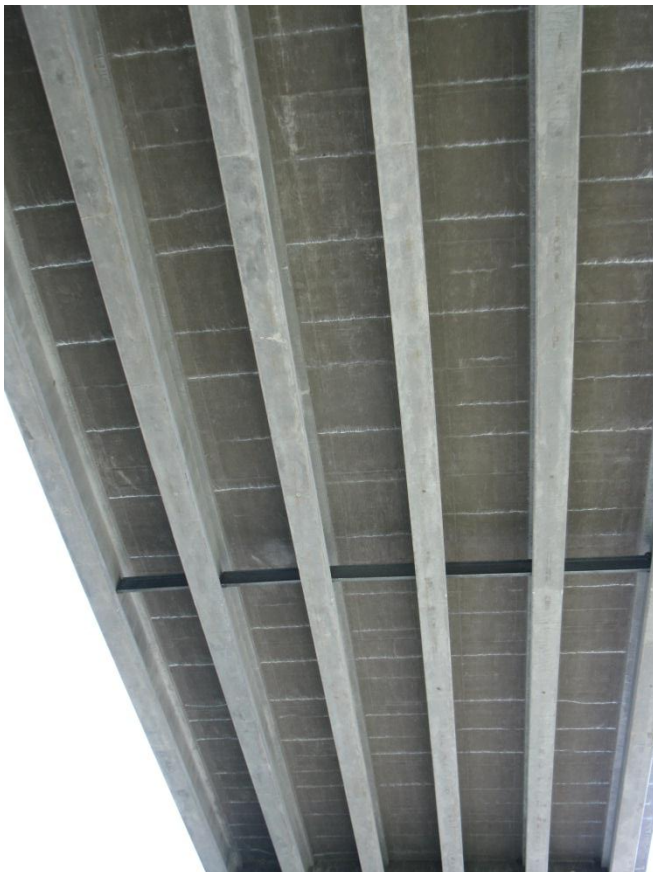
Figure 44. Area of typical transverse cracking with efflorescence at underside of west approach spans for the US 30 bridge.

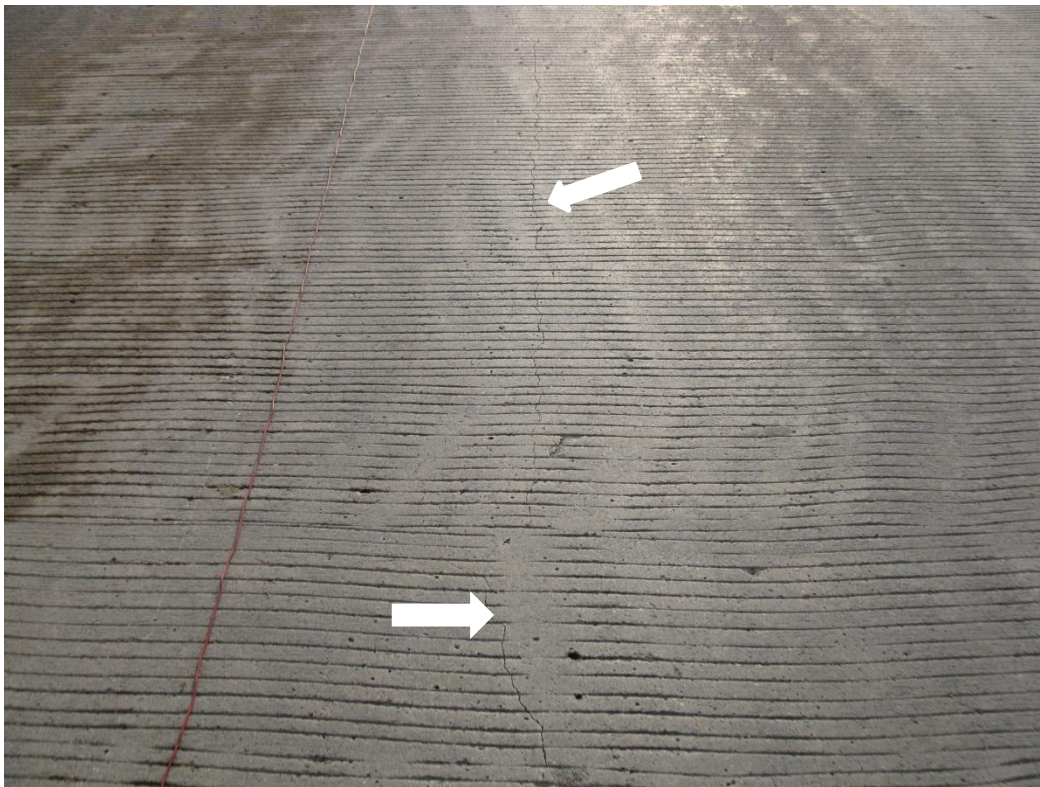
Figure 46. Typical view of longitudinal crack in US 18 bridge deck.

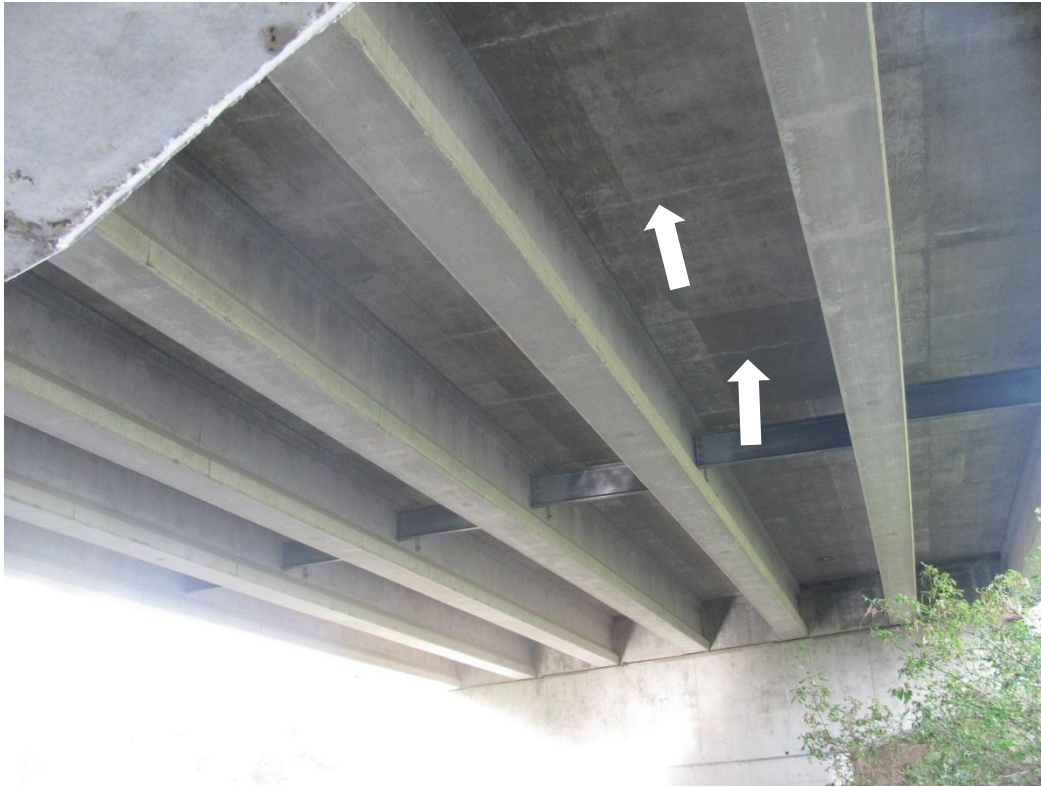
Figure 47. Typical view of underside of center span of US 18 bridge deck, with cracking indicated by arrows.

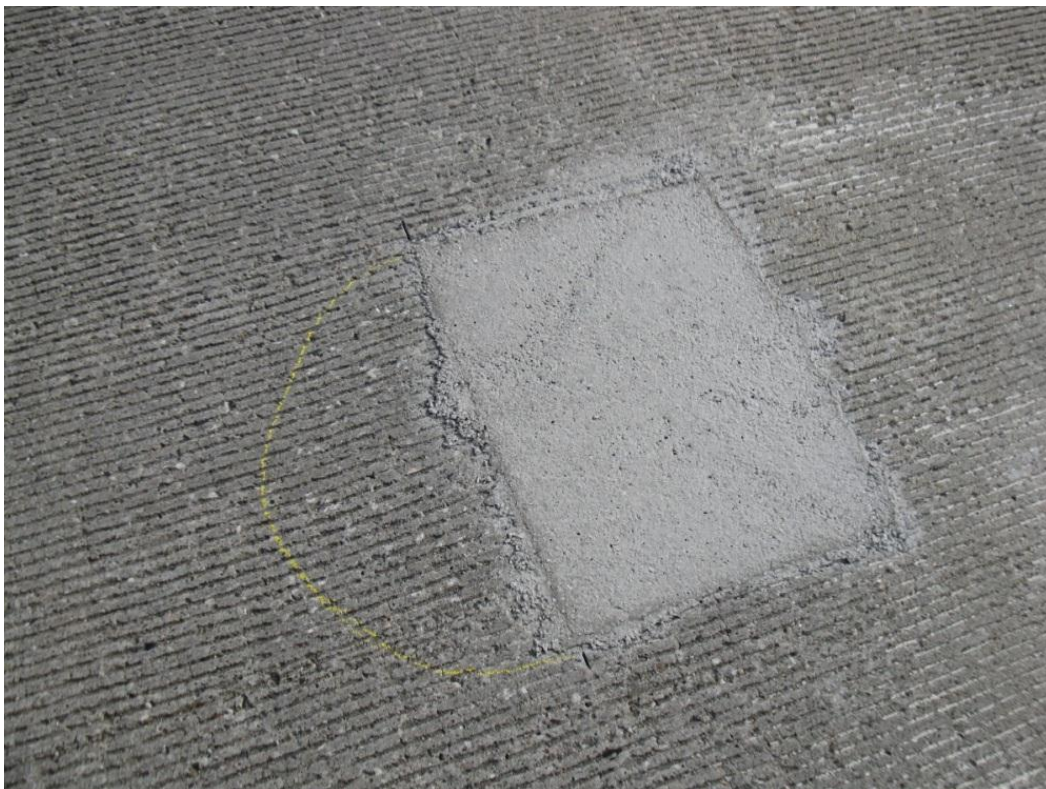
Figure 48. Area of patching on top surface of Southbound US 65 bridge deck, with adjacent area of delaminated concrete outlined in yellow.

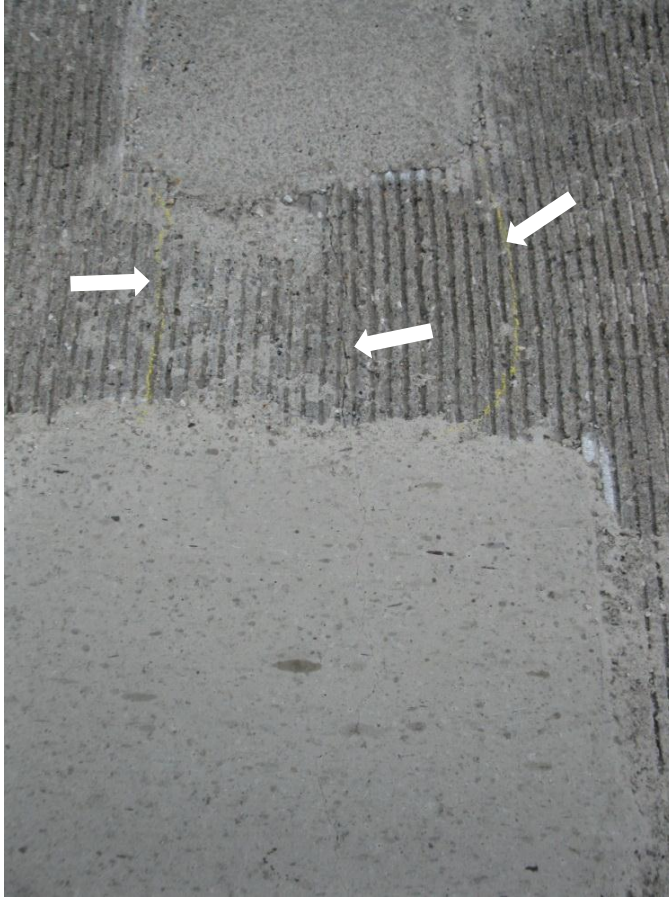
Figure 49. Area of delaminated concrete outlined in yellow between two patches and along a transverse crack in the Southbound US 65 bridge deck.

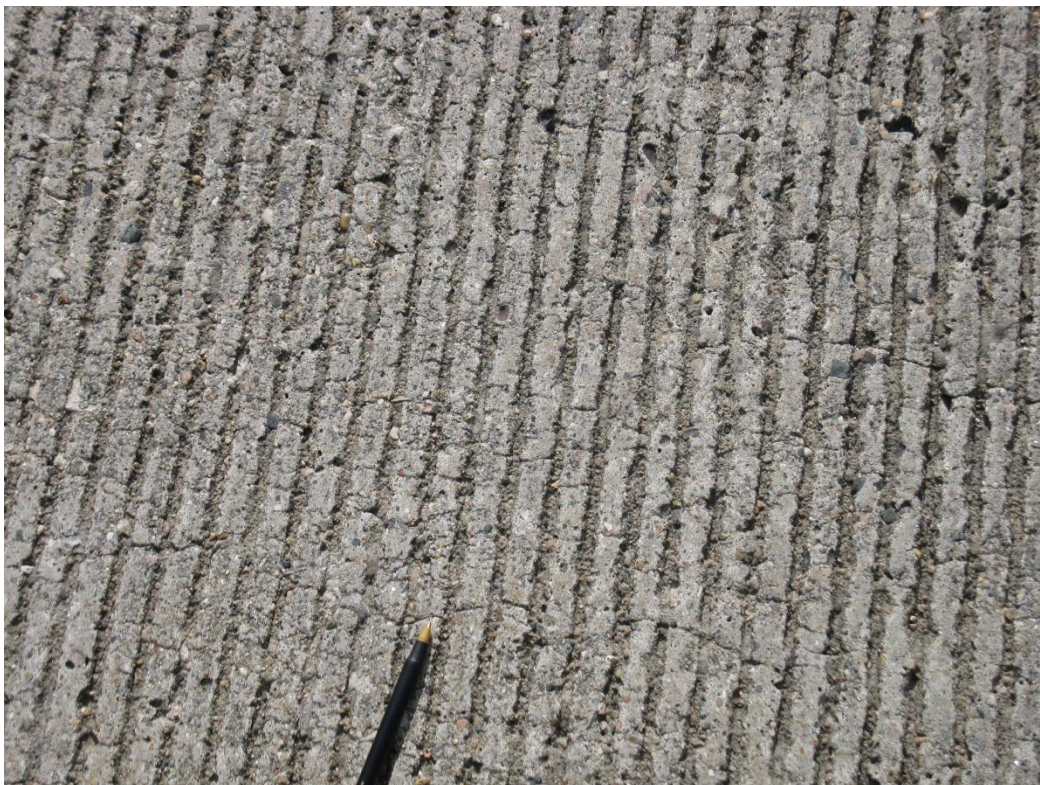
Figure 50. Fine hairline cracking in deck top surface with the appearance of plastic shrinkage cracking.

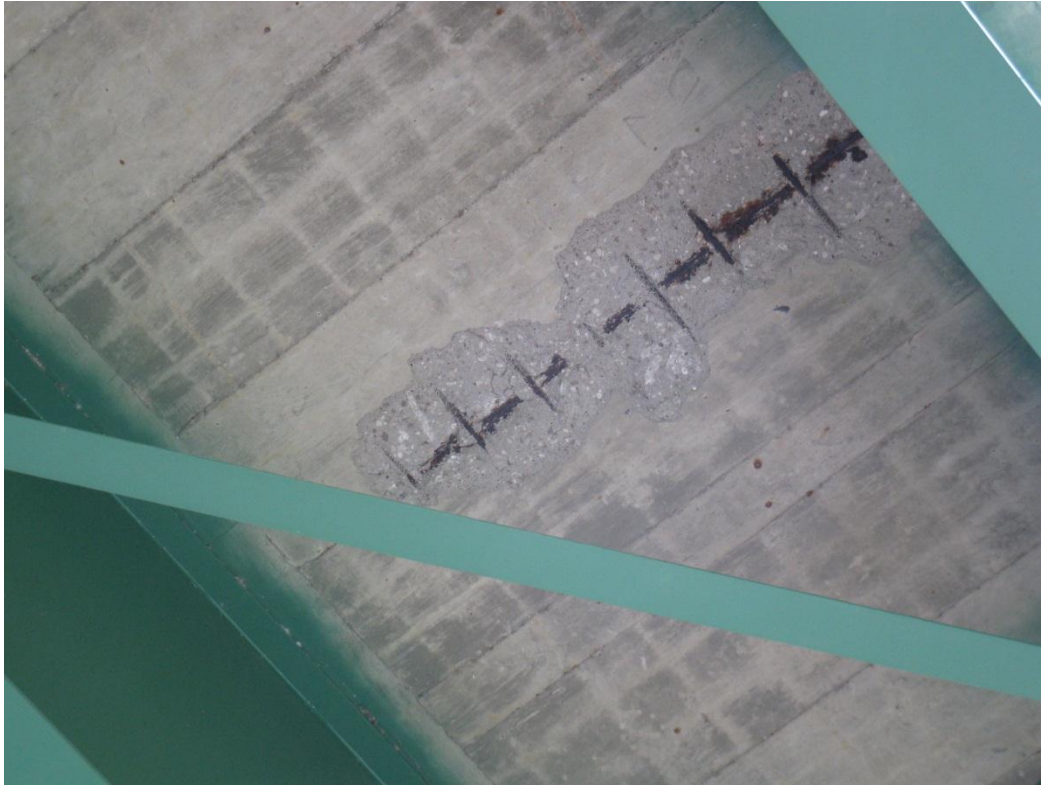
Figure 51. Area of spalled concrete on underside of Southbound US 65 bridge deck

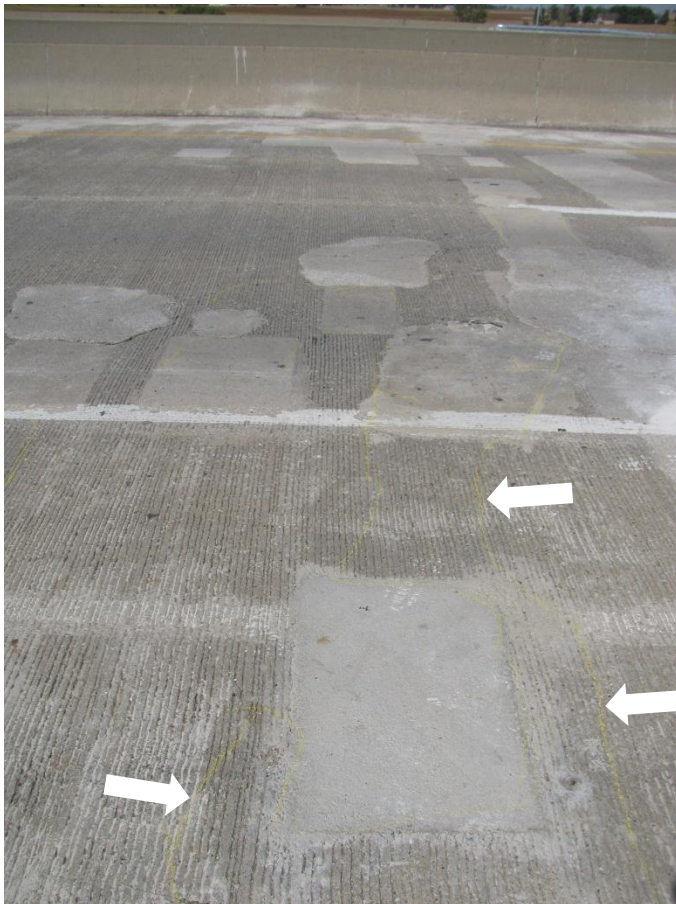
Figure 52. Area of extensive patching on the surface of Northbound US 65 bridge deck, with adjacent delaminations outlined in yellow.

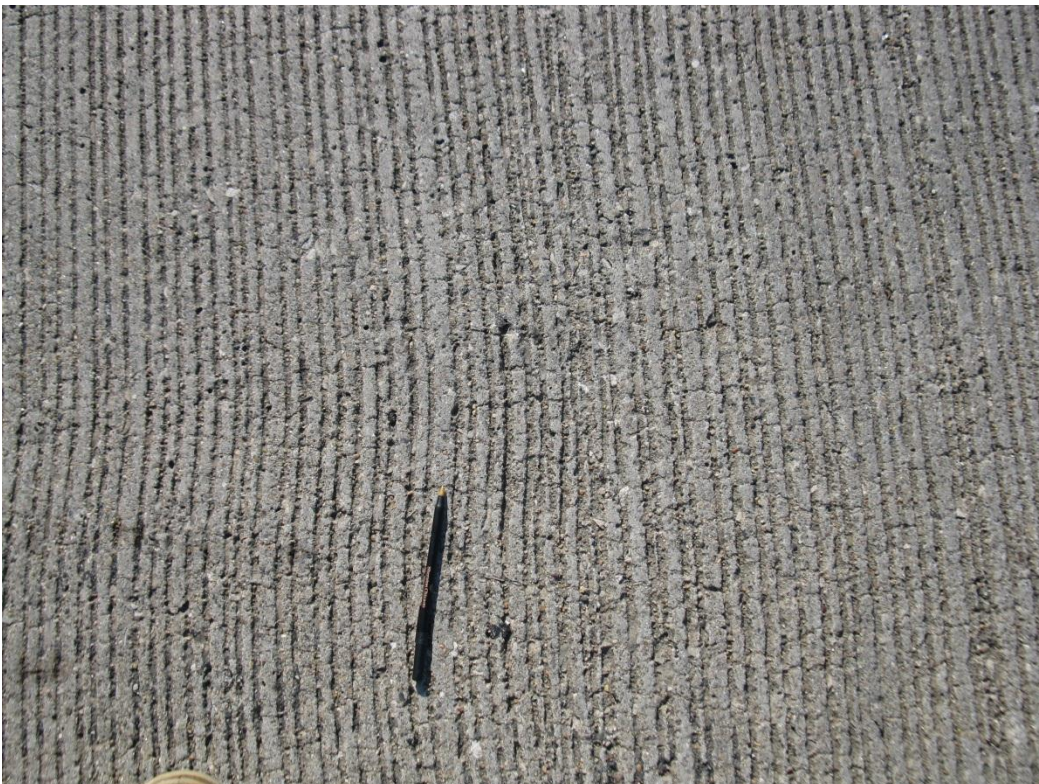
Figure 54. Multiple short hairline cracks on deck top surface (Northbound US 65) similar to plastic shrinkage cracking.

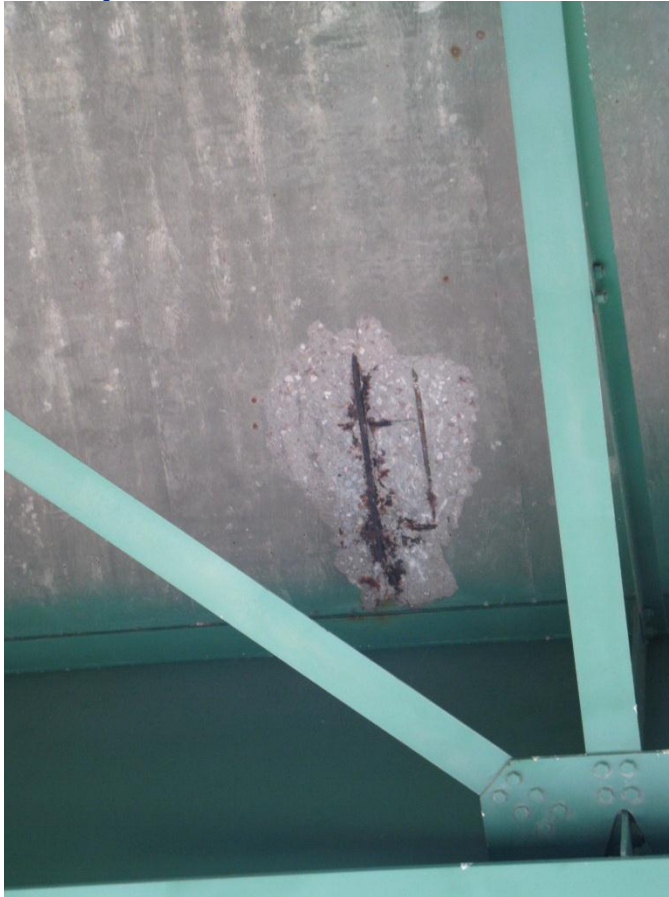
Figure 55. Area of spalled concrete on underside of Northbound US 65 deck.

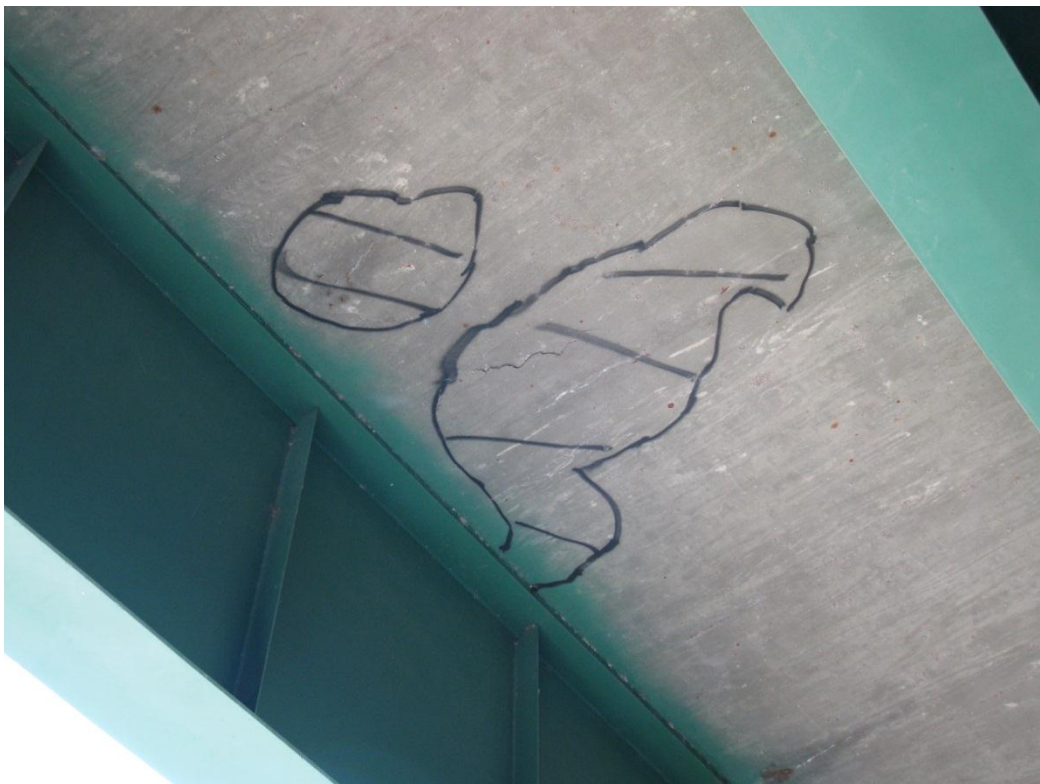
Figure 56. Marked areas of delamination on underside of Northbound US 65 bridge deck (marked by others).

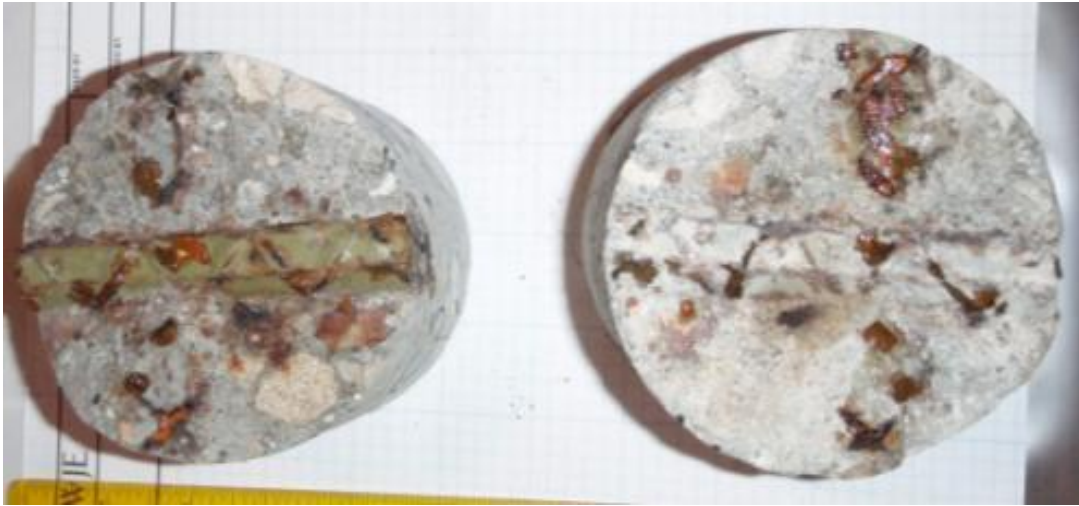
Figure 25. The inner crack faces of the horizontal delamination plane in Core US 65 NB #6.

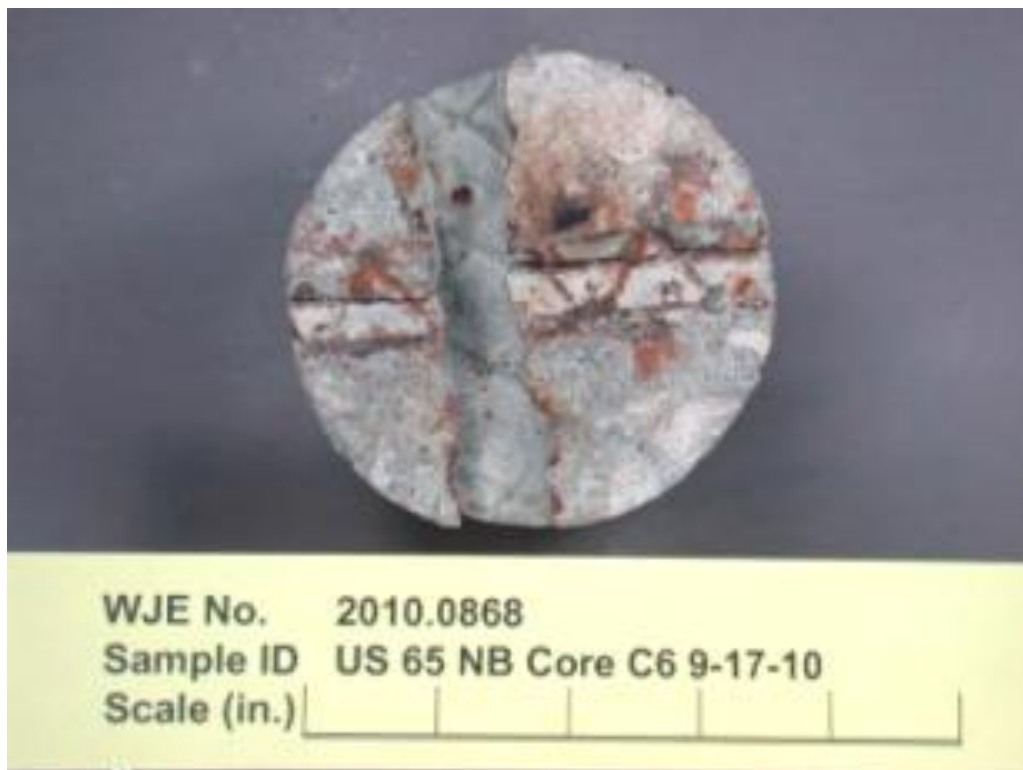
Figure 27. The as-received appearance of the bottom of the top section of Core US 65 NB #6 showing multiple cracks at the location of the removed reinforcing.

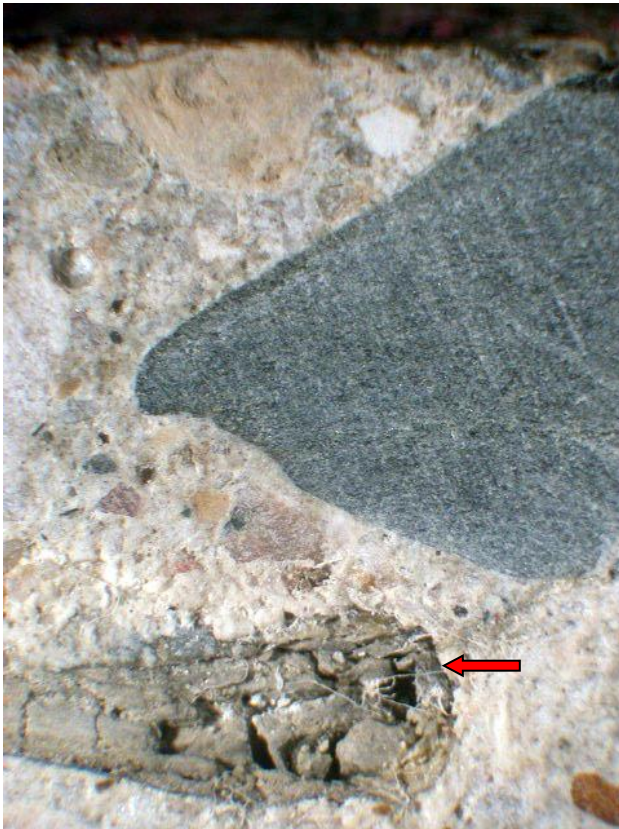
Figure 41. A non-durable shale particle that is embedded near the surface of Core US 18 #8 is marked with an arrow. The particle is intersected by a fracture that is oriented approximately horizontally. The height of the field of view is 0.5 inch in this photo.

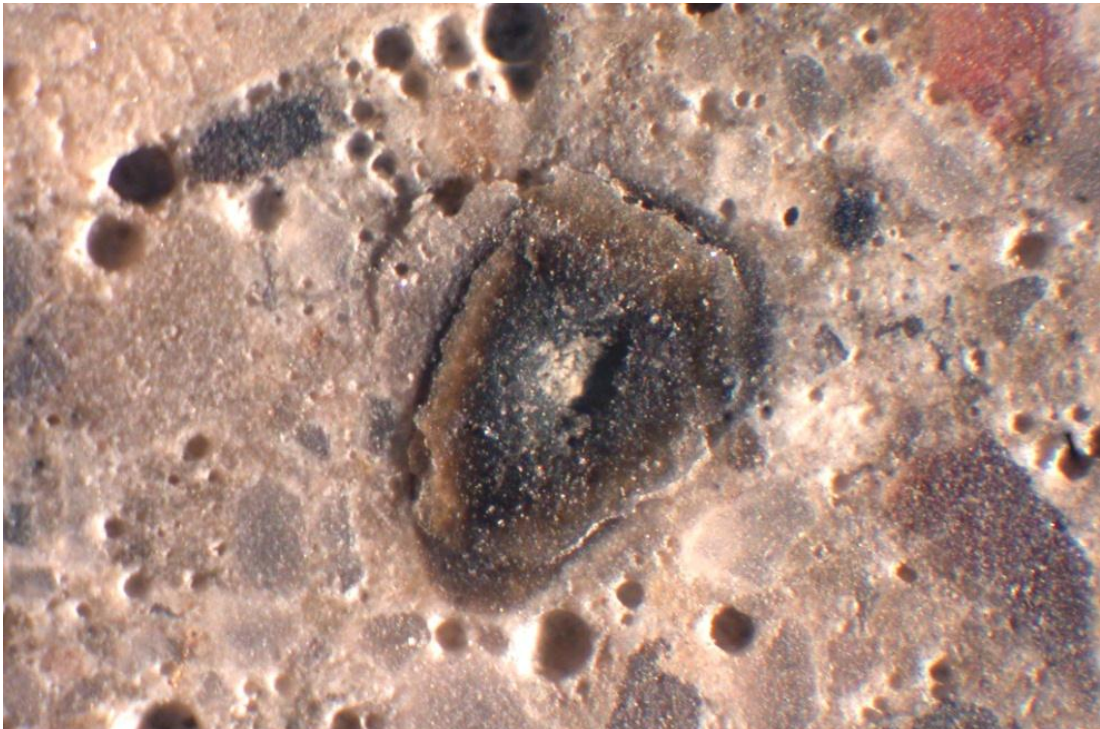
Figure 42. A sand particle that expanded after it was exposed on a lapped surface of Core IA 17 #1. The height of the field of view is 0.18 inch.

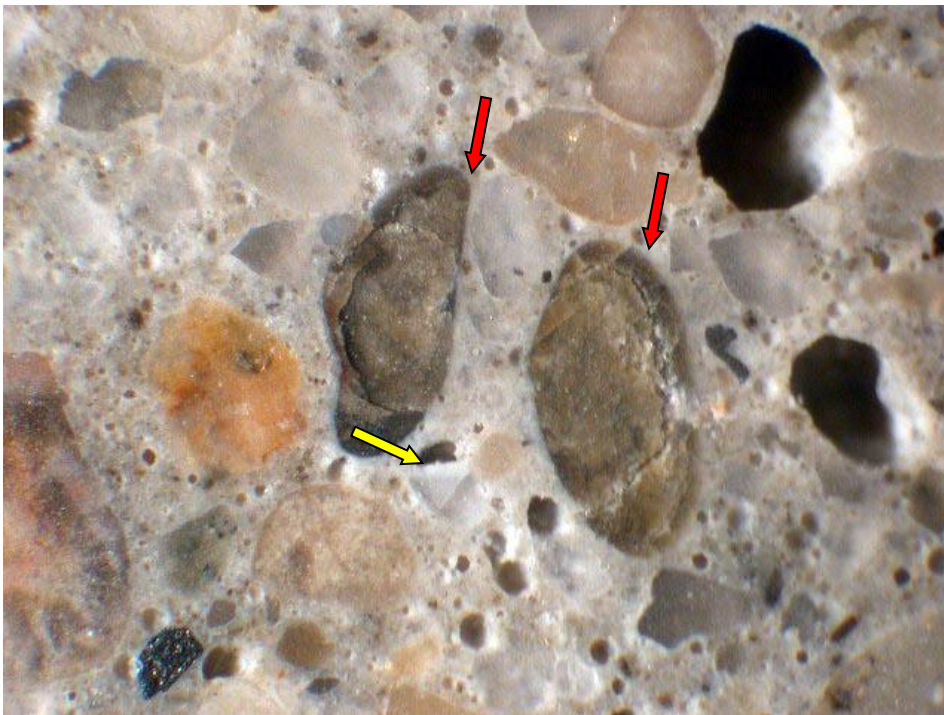
Figure 43. Two internally fractured sand particles contained in Core IA 17 #1 are marked with red arrows. The yellow arrow marks a void that is partially filled with silica gel, which is indicative of ASR. The width of the field of view is 0.15 inch.
